**Flood Control Project Maintenance
Levee Inspections**

Fall 2012 Levee Maintenance Deficiency Summary Report

Reclamation District No. 0150 Merrit Island

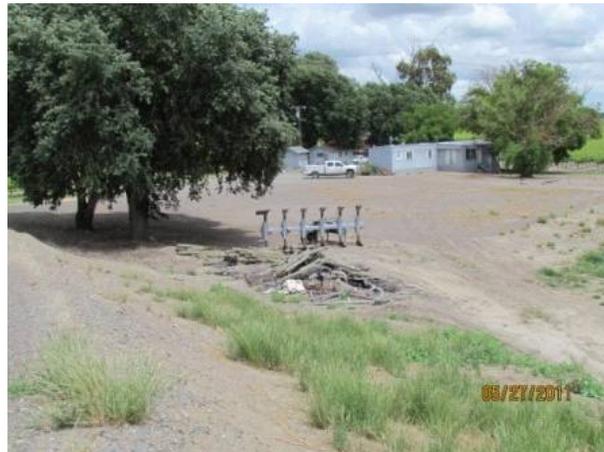
Levee Mile Report Line	33
Start Levee Mile	3.95
End Levee Mile	3.95
Location	Land Side
Category	Earthen Levee
Item	Encroachments
Debris found on the landside of the levee during Spring 2011 inspection. The picture was taken from the crown looking upstream.	
pkazi_f_20120913_699.jpg

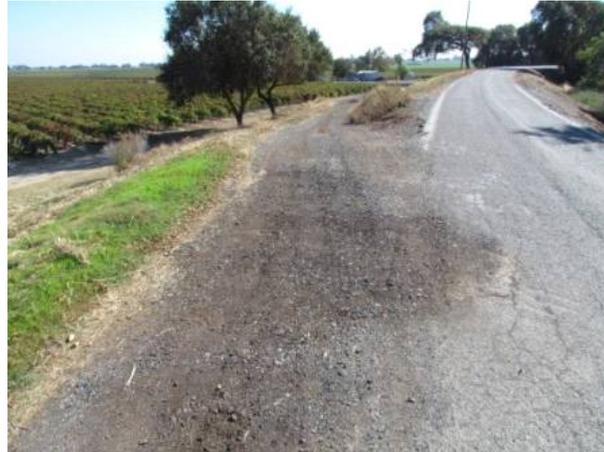
Levee Mile Report Line	35
Start Levee Mile	4.05
End Levee Mile	4.05
Location	Crown
Category	Earthen Levee
Item	Crown Surface / Depressions / Rutting
Crown depression was fixed by the LMA looking downstream.	
pkazi_f_20121101_994.jpg

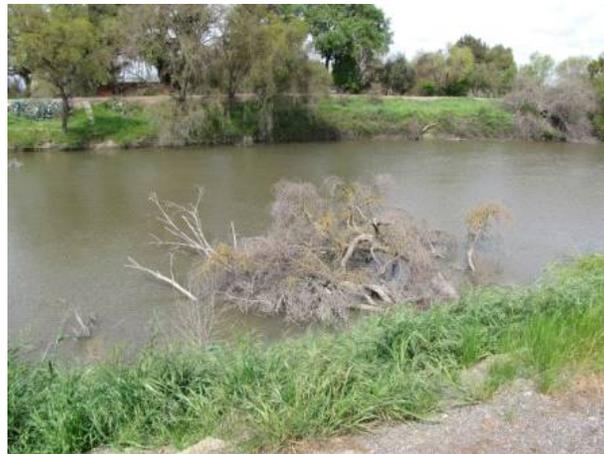
Levee Mile Report Line	38
Start Levee Mile	4.35
End Levee Mile	4.35
Location	Water Side
Category	Earthen Levee
Item	Trim / Thin Trees
View of tree stumps on the waterward slope.	
pkazi_f_20120913_690.jpg

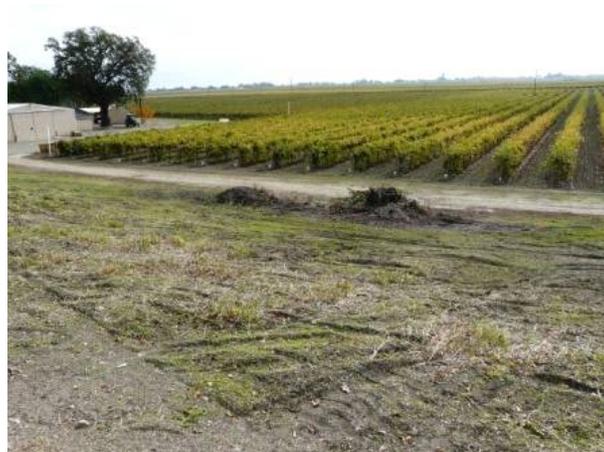
Levee Mile Report Line	39
Start Levee Mile	4.46
End Levee Mile	4.46
Location	Land Side
Category	Earthen Levee
Item	Encroachments
Remove pruning pile on landward slope at LM 4.46.	
pkazi_f_20120913_702.JPG

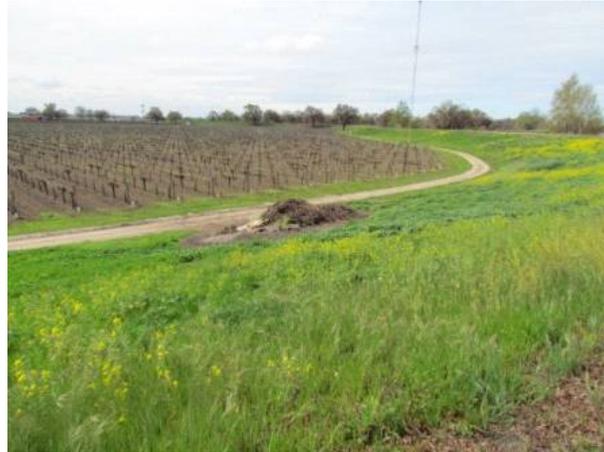
Levee Mile Report Line	39
Start Levee Mile	4.46
End Levee Mile	4.46
Location	Land Side
Category	Earthen Levee
Item	Encroachments
Pruning was found on the landside of the levee looking downstream.	
pkazi_f_20120913_703.jpg

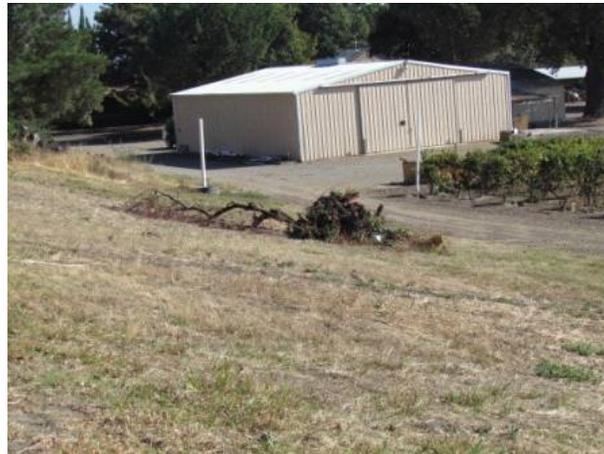
Levee Mile Report Line	39
Start Levee Mile	4.46
End Levee Mile	4.46
Location	Land Side
Category	Earthen Levee
Item	Encroachments
Pruning was found on the landside of the levee looking upstream. This picture was taken during fall 2012 inspection.	
pkazi_f_20121101_993.jpg

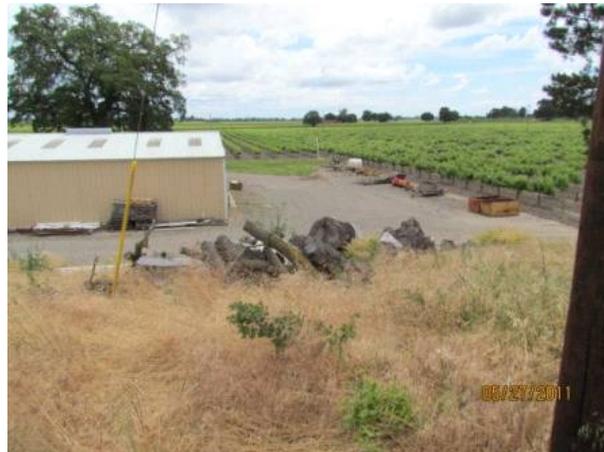
Levee Mile Report Line	40
Start Levee Mile	4.51
End Levee Mile	4.51
Location	Land Side
Category	Earthen Levee
Item	Encroachments
Tree branches were found on the toe of landside of the levee. The picture was taken from the crown looking downstream.	
pkazi_f_20120913_704.jpg

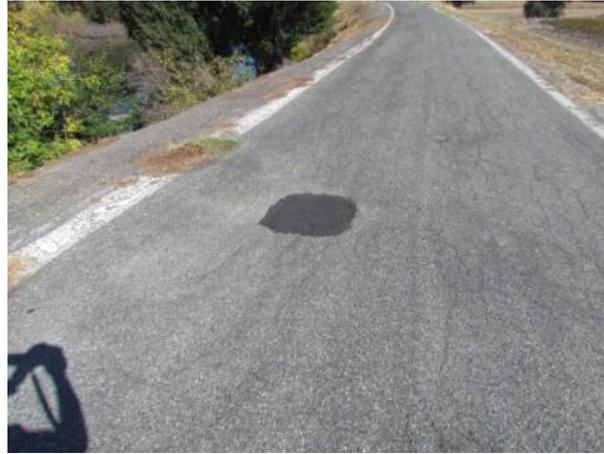
Levee Mile Report Line	43
Start Levee Mile	4.74
End Levee Mile	4.74
Location	Crown
Category	Earthen Levee
Item	Crown Surface / Depressions / Rutting
Crown depression was repaired by the LMA looking upstream.	
pkazi_f_20121101_992.jpg

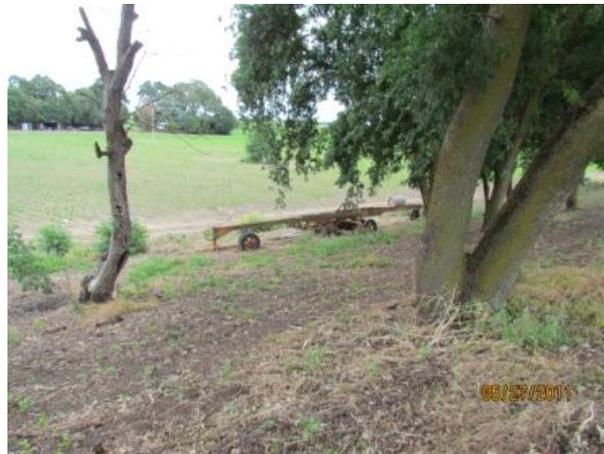
Levee Mile Report Line	45
Start Levee Mile	4.98
End Levee Mile	4.98
Location	Land Side
Category	Earthen Levee
Item	Encroachments
Equipment on the landside toe of the levee. The picture was taken from crown looking downstream.	
pkazi_f_20120913_664.jpg

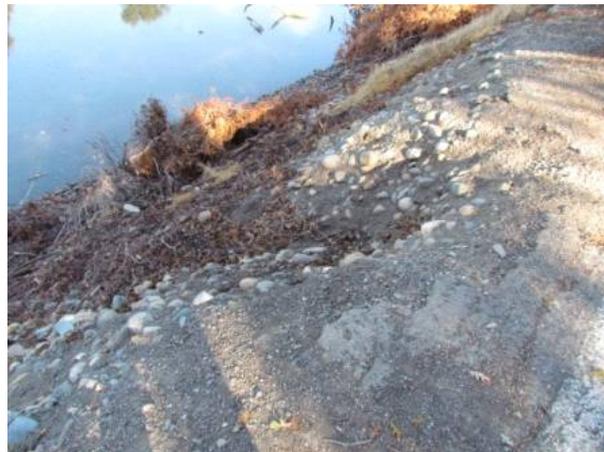
Levee Mile Report Line	46
Start Levee Mile	5.08
End Levee Mile	5.08
Location	Water Side
Category	Earthen Levee
Item	Slope Stability
Slope instability was found on the waterside of the levee looking upstream.	
pkazi_f_20121101_980.jpg

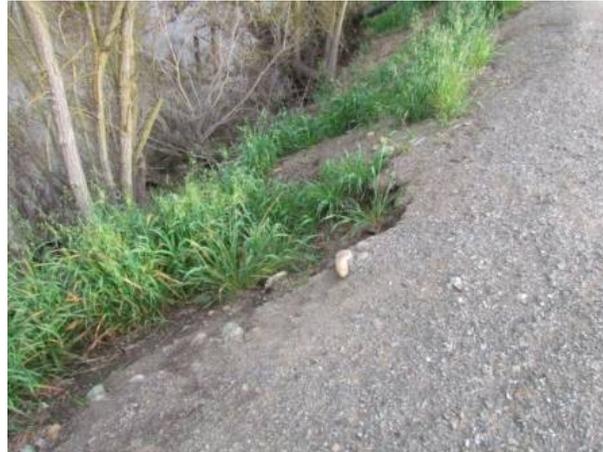
pkazi_f_20120913_659.jpg

Slope instability was found on the waterside of the levee looking upstream.

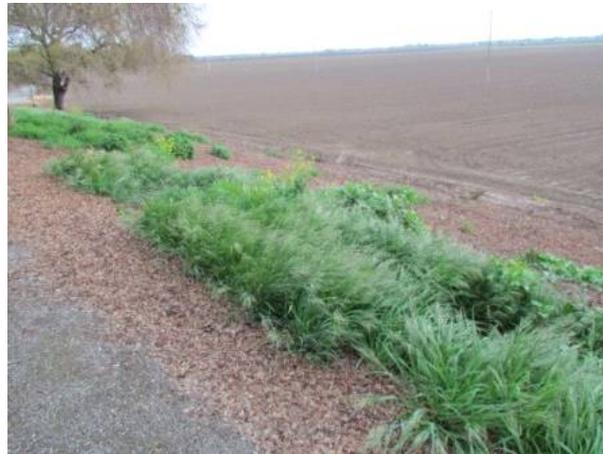
pkazi_f_20120913_663.jpg

Levee Mile Report Line	50
Start Levee Mile	5.20
End Levee Mile	5.20
Location	Land Side
Category	Earthen Levee
Item	Vegetation

Vegetation on the landside of the levee looking upstream.

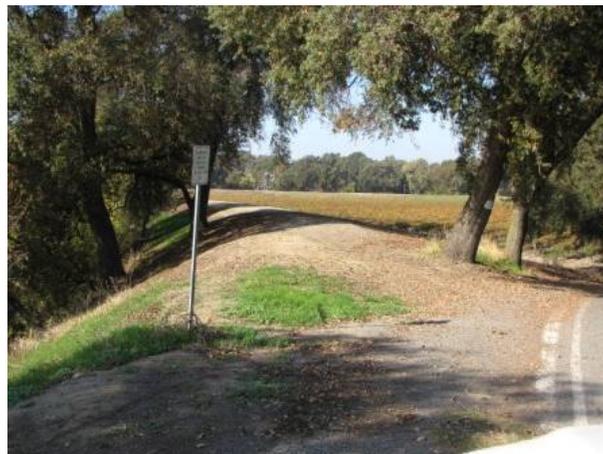
pkazi_f_20120913_752.jpg

Levee Mile Report Line	51
Start Levee Mile	5.22
End Levee Mile	5.22
Location	Crown
Category	Earthen Levee
Item	Crown Surface / Depressions / Rutting

View of varying elevations in the crown of the levee at the transition from county road to access road.

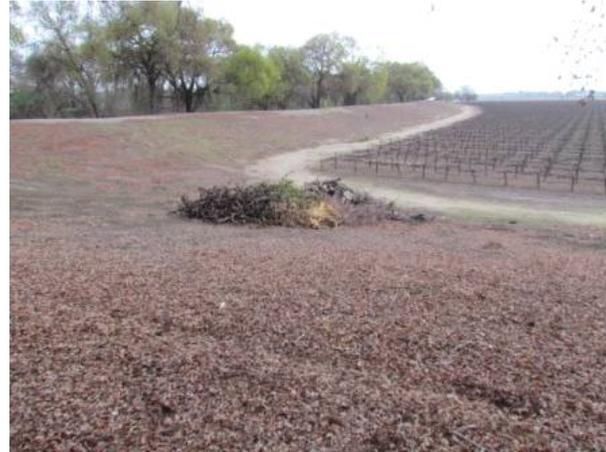
Levee Mile Report Line	52
Start Levee Mile	5.61
End Levee Mile	5.61
Location	Land Side
Category	Earthen Levee
Item	Encroachments
Prunings were found on the landside of the levee looking upstream.	
pkazi_f_20120913_668.jpg

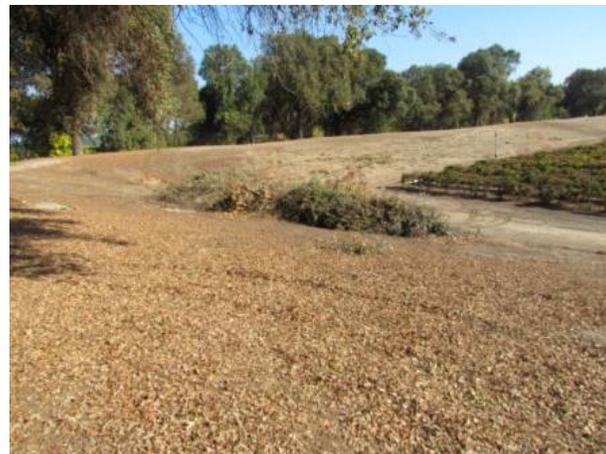
Levee Mile Report Line	52
Start Levee Mile	5.61
End Levee Mile	5.61
Location	Land Side
Category	Earthen Levee
Item	Encroachments
Pruning was found on the landside toe of the levee looking upstream. This picture was taken during fall 2012 inspection.	
pkazi_f_20121101_981.jpg

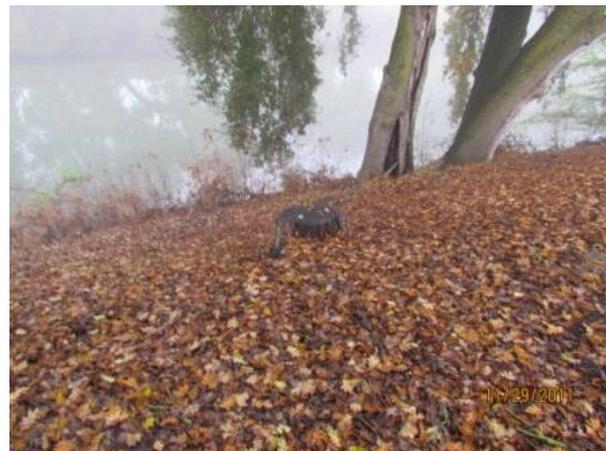
Levee Mile Report Line	53
Start Levee Mile	5.66
End Levee Mile	5.66
Location	Water Side
Category	Earthen Levee
Item	Trim / Thin Trees
Tree stump was found on the waterside of the levee looking upstream.	
pkazi_f_20120913_721.jpg

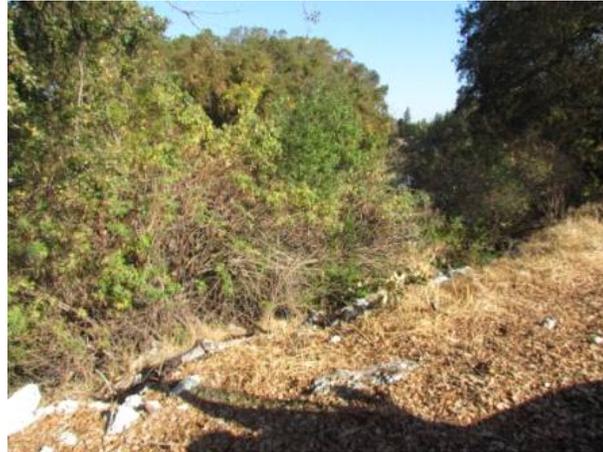
Levee Mile Report Line	55
Start Levee Mile	5.88
End Levee Mile	5.88
Location	Water Side
Category	Earthen Levee
Item	Vegetation
Wild growth was found on the waterside slope of the levee looking upstream.	
pkazi_f_20121101_982.jpg

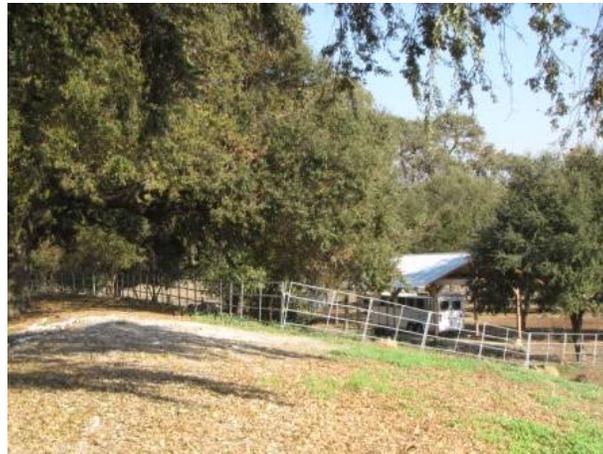
Levee Mile Report Line	56
Start Levee Mile	5.89
End Levee Mile	5.94
Location	Land Side
Category	Earthen Levee
Item	Encroachments
View of fence around a horse pen along the shoulder of the levee and the landward slope.	
pkazi_f_20120913_708.jpg

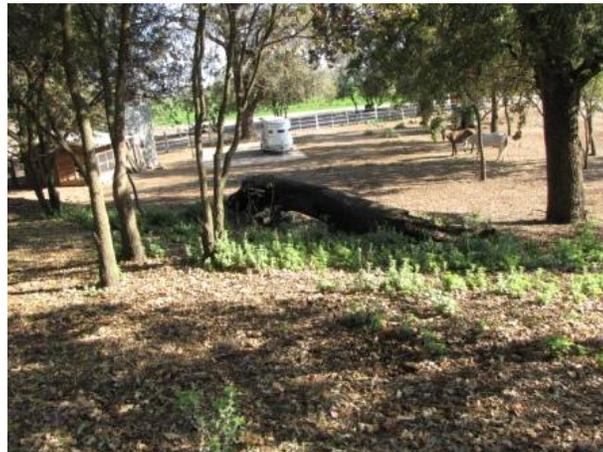
Levee Mile Report Line	57
Start Levee Mile	5.93
End Levee Mile	5.93
Location	Land Side
Category	Earthen Levee
Item	Encroachments
View of a tree trunk lying on the landward slope blocking visibility.	
pkazi_f_20120913_709.jpg

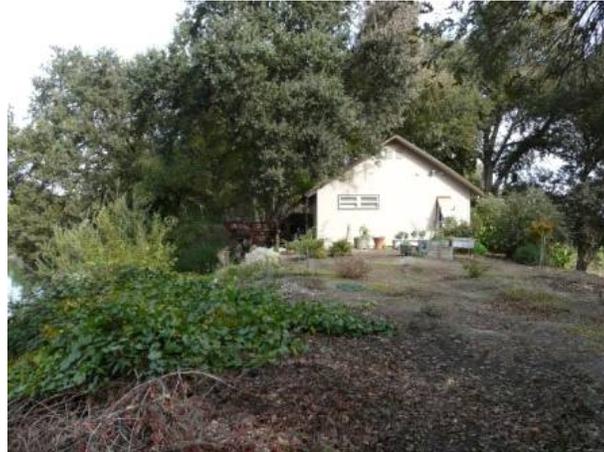
Levee Mile Report Line	58
Start Levee Mile	5.93
End Levee Mile	5.93
Location	Crown
Category	Earthen Levee
Item	Encroachments
Building & associated landscaping on levee crown at LM 5.93.	
pkazi_f_20120913_710.JPG

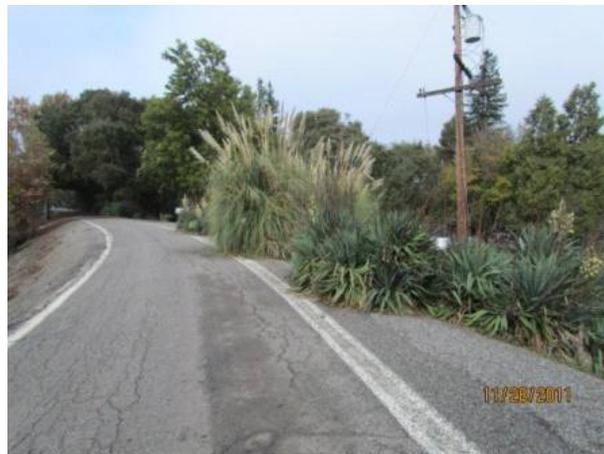
Levee Mile Report Line	59
Start Levee Mile	6.01
End Levee Mile	6.09
Location	Land Side
Category	Earthen Levee
Item	Vegetation
Landscaping was found on the landside of the levee looking upstream.	
pkazi_f_20120913_678.jpg

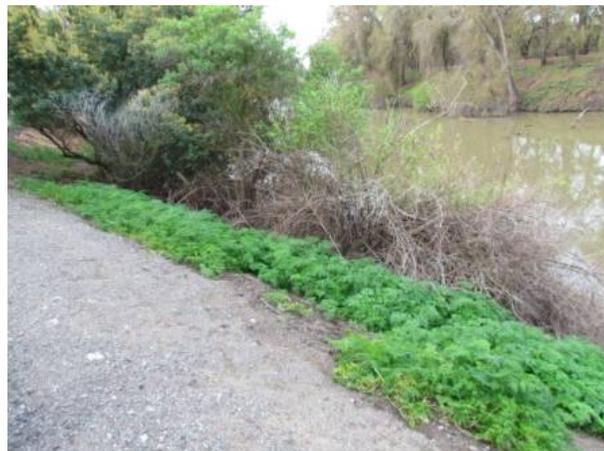
Levee Mile Report Line	60
Start Levee Mile	6.05
End Levee Mile	6.05
Location	Water Side
Category	Earthen Levee
Item	Trim / Thin Trees
Tree trunks and vegetation was obstructing the visibility on the waterside slope of the levee looking downstream.	
pkazi_f_20120913_687.jpg

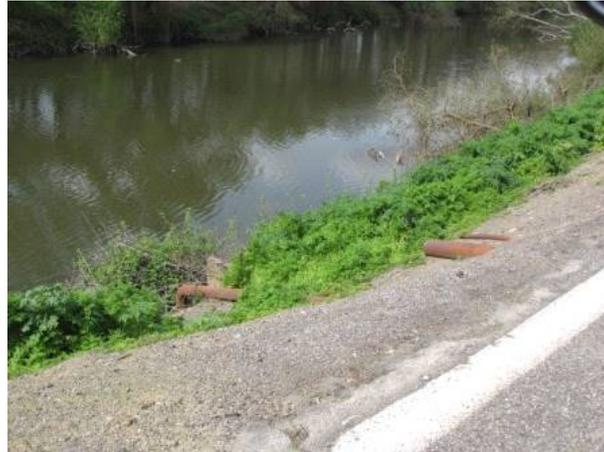
pkazi_f_20120913_695.jpg

View of an improperly abandoned pipe through the levee looking upstream.

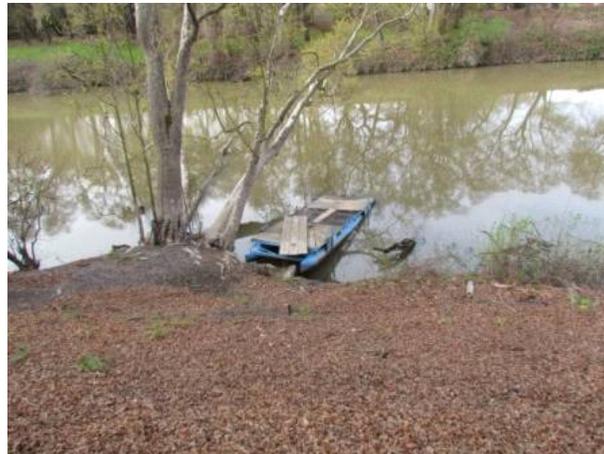
pkazi_f_20120913_693.jpg

Levee Mile Report Line	62
Start Levee Mile	6.14
End Levee Mile	6.14
Location	Water Side
Category	Earthen Levee
Item	Encroachments

An abandoned dock was found on the waterside of the levee looking upstream.

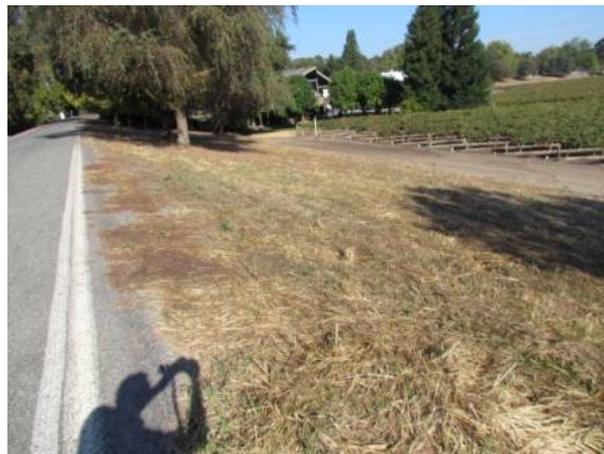
pkazi_f_20121101_983.jpg

Levee Mile Report Line	65
Start Levee Mile	6.18
End Levee Mile	6.18
Location	Land Side
Category	Earthen Levee
Item	Vegetation

Vegetation was removed by the LMA on the landside of the levee looking upstream.

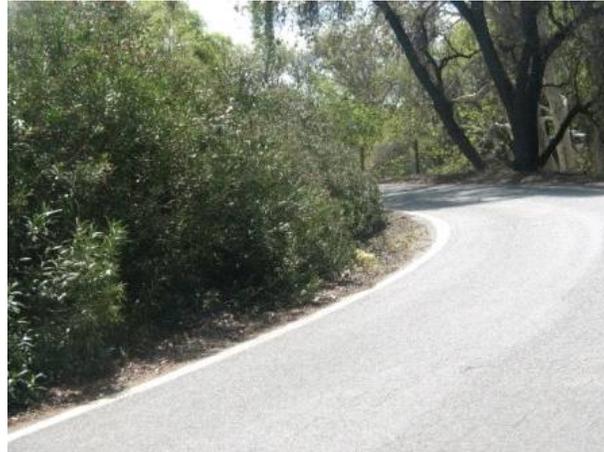
Levee Mile Report Line	66
Start Levee Mile	6.24
End Levee Mile	6.31
Location	Land Side
Category	Earthen Levee
Item	Vegetation
Oleander on landward slope blocking view of levee from LM 6.24 to 6.32	
pkazi_f_20120913_680.jpg

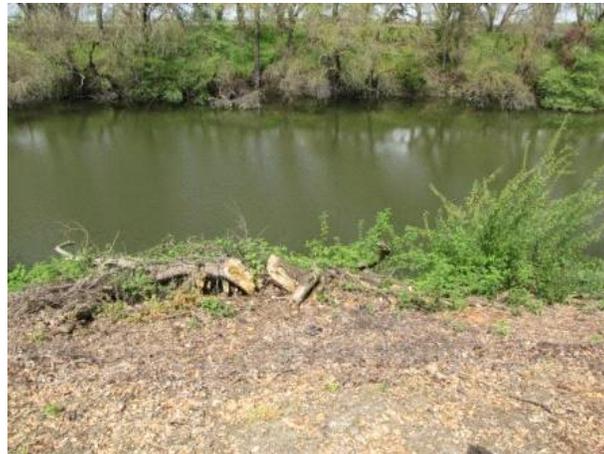
Levee Mile Report Line	67
Start Levee Mile	6.34
End Levee Mile	6.34
Location	Water Side
Category	Earthen Levee
Item	Trim / Thin Trees
View of tree stumps on the waterward slope.	
pkazi_f_20120913_700.jpg

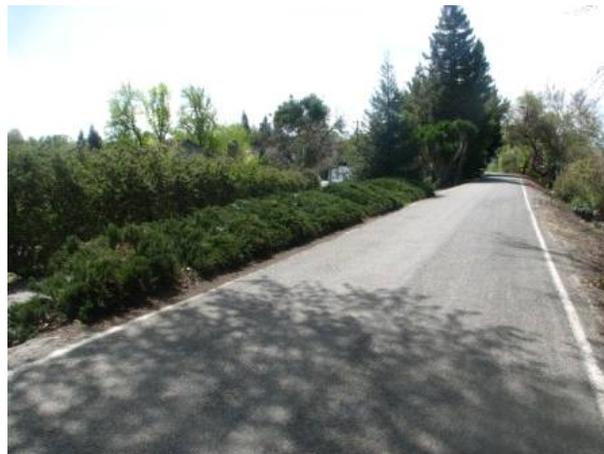
Levee Mile Report Line	69
Start Levee Mile	6.37
End Levee Mile	6.40
Location	Land Side
Category	Earthen Levee
Item	Vegetation
Landscaping on landward slope blocking view from LM 6.37 to 6.40	
pkazi_f_20120913_681.jpg

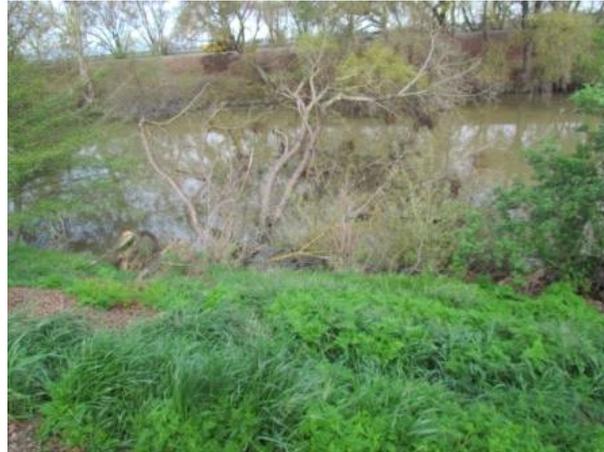
Vegetation on the waterside of the levee looking downstream.

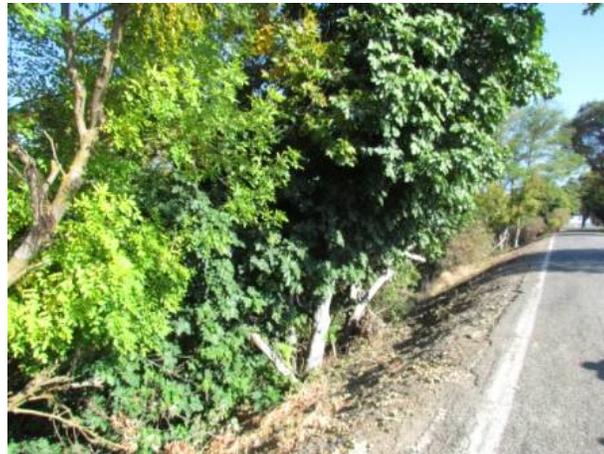
Levee Mile Report Line	70
Start Levee Mile	6.49
End Levee Mile	6.49
Location	Water Side
Category	Earthen Levee
Item	Trim / Thin Trees

Tree was blocking the visibility on the waterside of the levee looking upstream. This picture was taken during fall 2012 inspection.

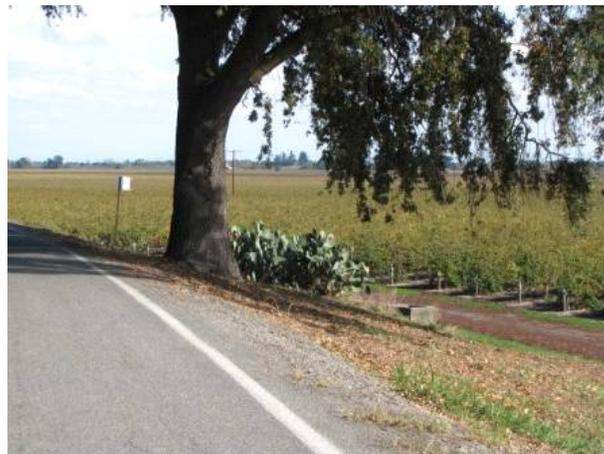
Levee Mile Report Line	71
Start Levee Mile	6.56
End Levee Mile	6.56
Location	Land Side
Category	Earthen Levee
Item	Vegetation

View of landscaping along the landward slope.

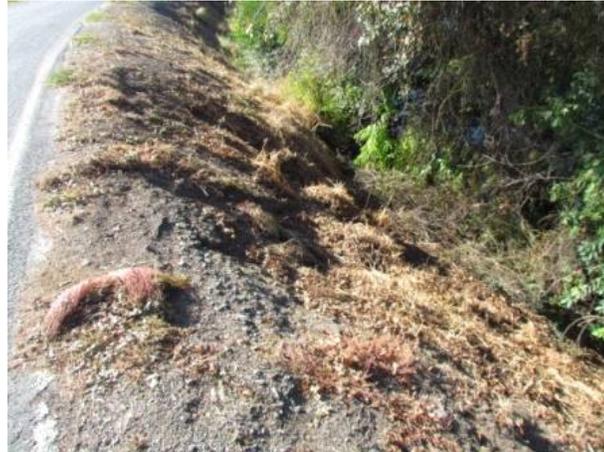
Levee Mile Report Line	72
Start Levee Mile	6.61
End Levee Mile	6.61
Location	Water Side
Category	Earthen Levee
Item	Slope Stability
Slope instability was found on the waterside of the levee looking downstream.	
pkazi_f_20121101_985.jpg

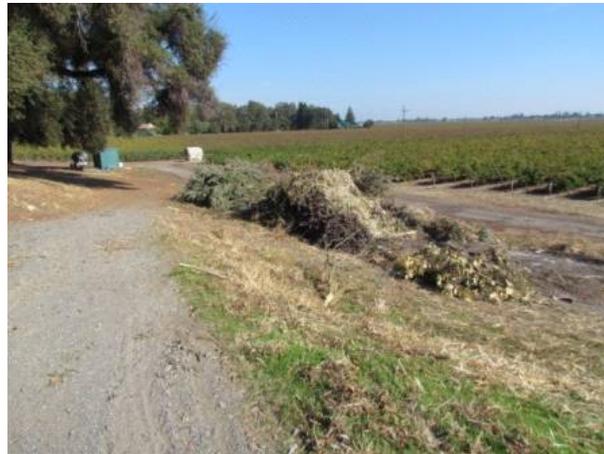
Levee Mile Report Line	73
Start Levee Mile	6.64
End Levee Mile	6.64
Location	Land Side
Category	Earthen Levee
Item	Encroachments
Pruning was found on the landside of the levee looking upstream.	
pkazi_f_20121101_986.jpg

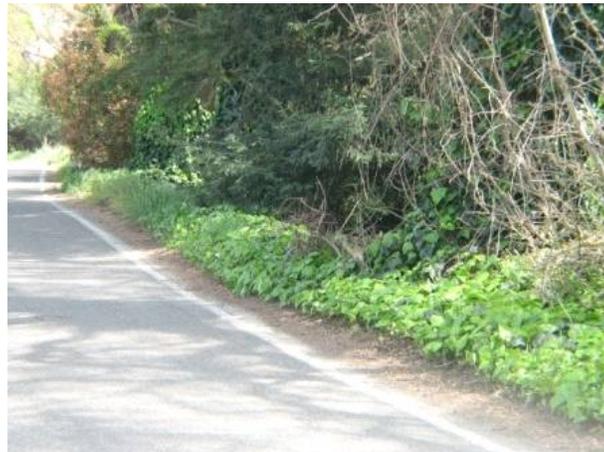
Levee Mile Report Line	74
Start Levee Mile	6.87
End Levee Mile	6.95
Location	Land Side
Category	Earthen Levee
Item	Vegetation
Landscaping on landward slope blocking view from LM 6.87 to 6.95	
pkazi_f_20120913_684.jpg

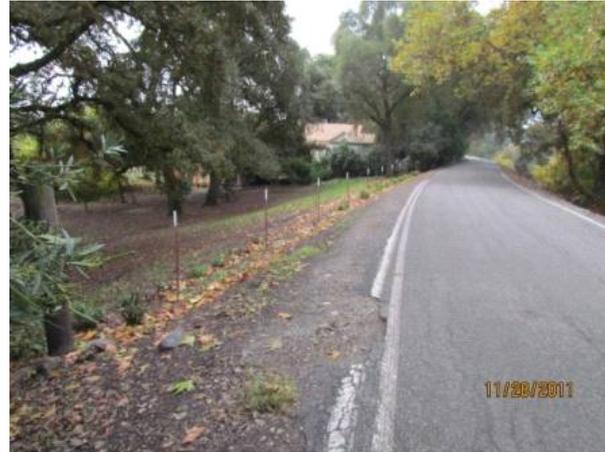
Levee Mile Report Line	75
Start Levee Mile	6.93
End Levee Mile	6.95
Location	Land Side
Category	Earthen Levee
Item	Encroachments
Fence was found on the landside of the levee looking downstream.	
pkazi_f_20120913_669.jpg

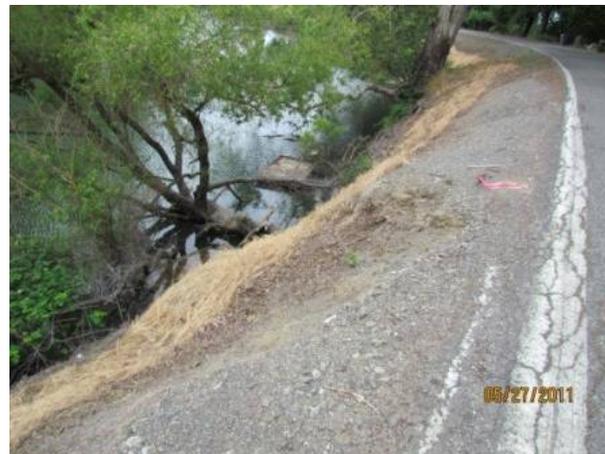
Levee Mile Report Line	78
Start Levee Mile	7.02
End Levee Mile	7.02
Location	Water Side
Category	Earthen Levee
Item	Erosion / Bank Caving
Updated erosion site picture on the waterside slope of the levee looking upstream during Spring 2011 inspection.	
pkazi_f_20120913_713.jpg

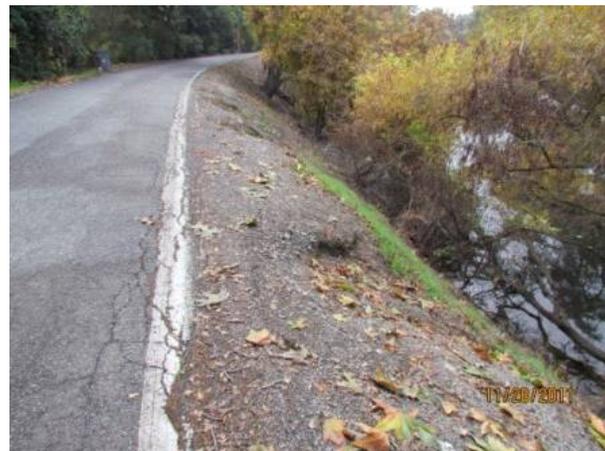
Levee Mile Report Line	78
Start Levee Mile	7.02
End Levee Mile	7.02
Location	Water Side
Category	Earthen Levee
Item	Erosion / Bank Caving
Erosion was found on the waterside of the levee looking downstream. This picture was taken during fall 2011 inspection.	
pkazi_f_20120913_714.jpg

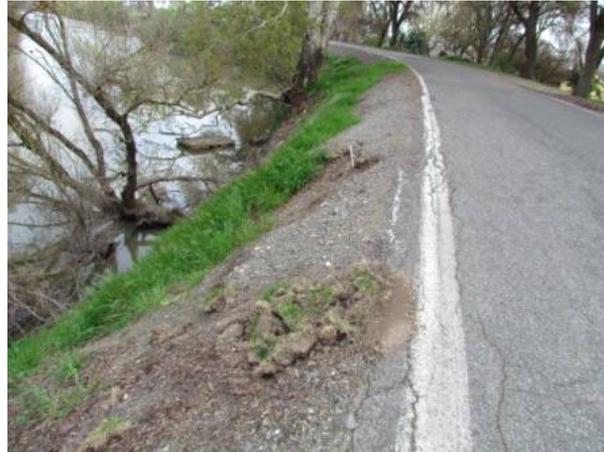
Erosion on the waterside of the levee looking upstream. This picture was taken during spring 2012 inspection.

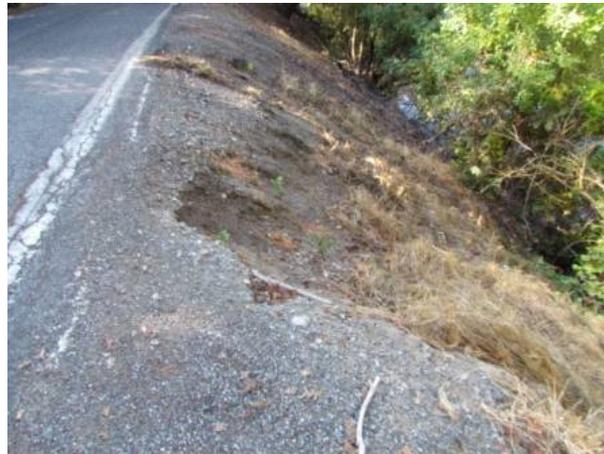
Levee Mile Report Line	78
Start Levee Mile	7.02
End Levee Mile	7.02
Location	Water Side
Category	Earthen Levee
Item	Erosion / Bank Caving

Erosion was found on the waterside slope of the levee looking downstream. This updated picture was taken during fall 2012 inspection.

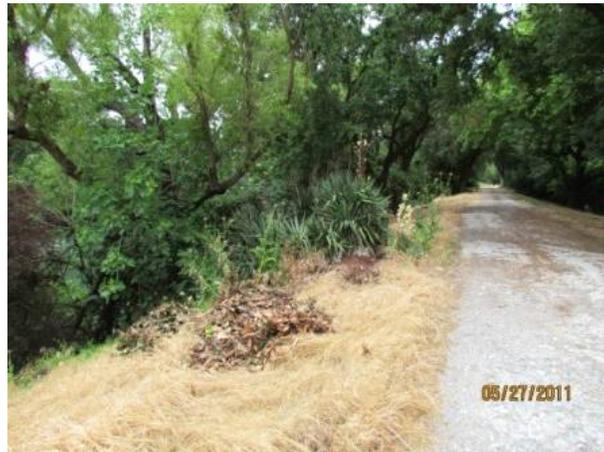
Levee Mile Report Line	80
Start Levee Mile	7.39
End Levee Mile	7.39
Location	Water Side
Category	Earthen Levee
Item	Vegetation

Landscaping on the waterside of the levee. The picture was taken from the crown looking upstream.

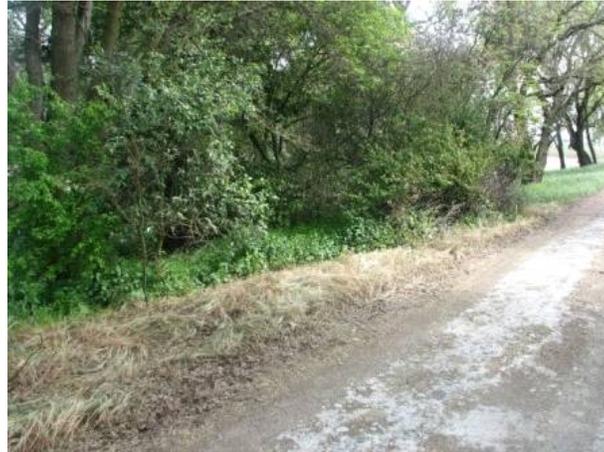
Levee Mile Report Line	81
Start Levee Mile	7.42
End Levee Mile	7.47
Location	Land Side
Category	Earthen Levee
Item	Vegetation
Landscaping on landward slope blocking view from LM 7.42 to 7.47	
pkazi_f_20120913_685.jpg

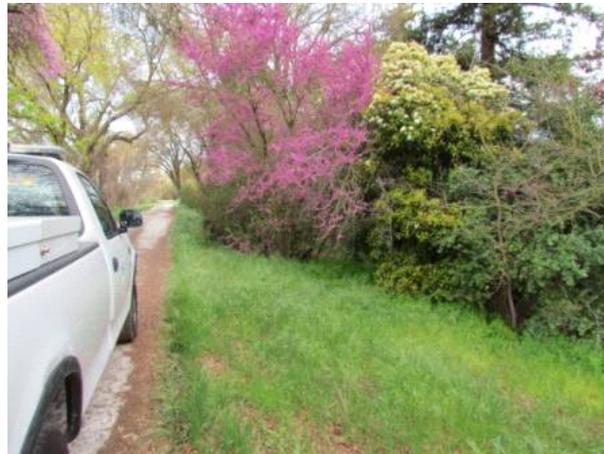
Levee Mile Report Line	81
Start Levee Mile	7.42
End Levee Mile	7.47
Location	Land Side
Category	Earthen Levee
Item	Vegetation
Vegetation on the landside of the levee looking upstream. This picture was taken during spring 2012 inspection.	
pkazi_f_20120913_686.jpg

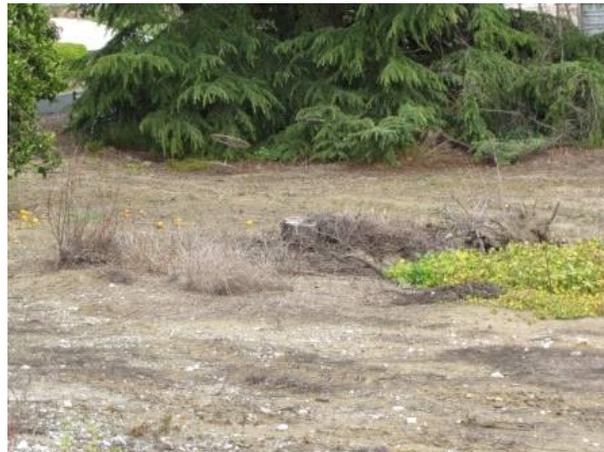
Levee Mile Report Line	83
Start Levee Mile	7.50
End Levee Mile	7.50
Location	Land Side
Category	Earthen Levee
Item	Trim / Thin Trees
View of a tree stump on the landward slope.	
pkazi_f_20120913_717.jpg

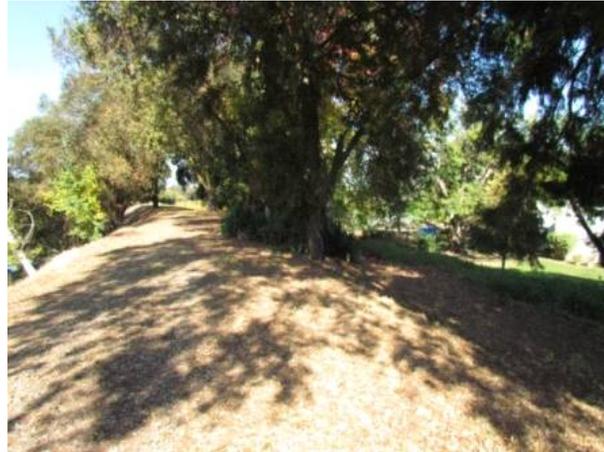
Levee Mile Report Line	84
Start Levee Mile	7.54
End Levee Mile	7.54
Location	Land Side
Category	Earthen Levee
Item	Vegetation
<p>Landscaping was found on the landside shoulder of the levee looking upstream.</p>	
<p>pkazi_f_20121101_988.jpg</p>

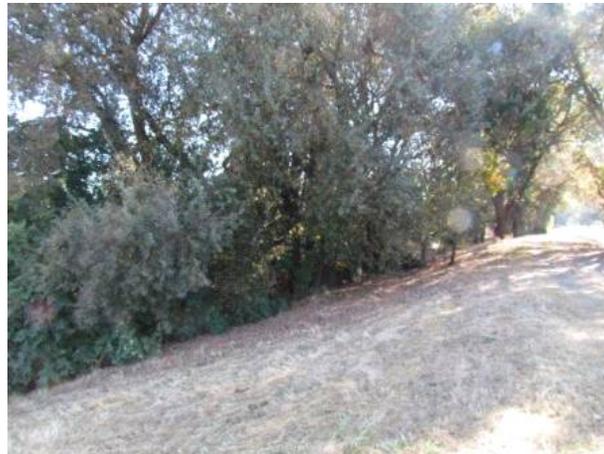
Levee Mile Report Line	86
Start Levee Mile	7.58
End Levee Mile	7.58
Location	Land Side
Category	Earthen Levee
Item	Vegetation
<p>Landscaping was blocking the visibility on the landside of the levee looking downstream.</p>	
<p>pkazi_f_20121101_989.jpg</p>

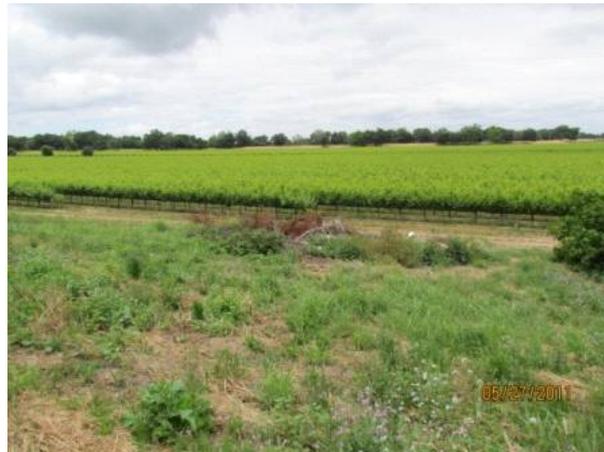
Levee Mile Report Line	87
Start Levee Mile	7.60
End Levee Mile	7.60
Location	Land Side
Category	Earthen Levee
Item	Encroachments
<p>Prunings located on the toe of landward side of the levee. The picture was taken from the crown looking upstream.</p>	
<p>pkazi_f_20120913_747.jpg</p>

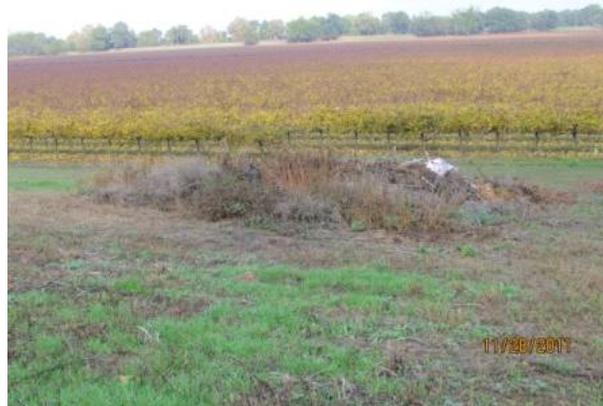
Levee Mile Report Line	87
Start Levee Mile	7.60
End Levee Mile	7.60
Location	Land Side
Category	Earthen Levee
Item	Encroachments
<p>Prunings were found on the landside of the levee looking upstream. This picture was taken during fall 2011 inspection.</p>	
<p>pkazi_f_20120913_748.jpg</p>

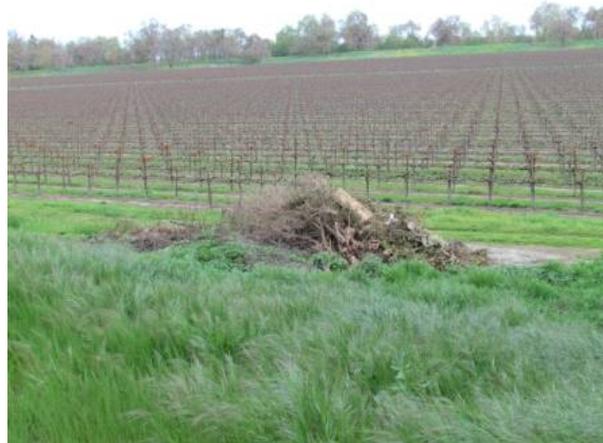
Levee Mile Report Line	87
Start Levee Mile	7.60
End Levee Mile	7.60
Location	Land Side
Category	Earthen Levee
Item	Encroachments
<p>Pruning was found on the landside of the levee looking upstream.</p>	
<p>pkazi_f_20120913_749.jpg</p>

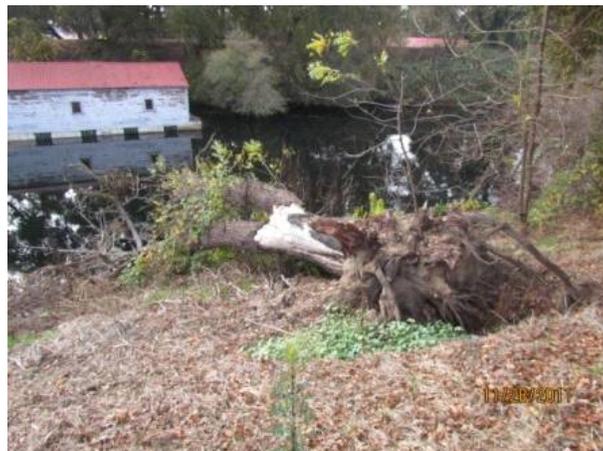
Levee Mile Report Line	89
Start Levee Mile	7.82
End Levee Mile	7.82
Location	Water Side
Category	Earthen Levee
Item	Encroachments
<p>Tree limb was found on the waterside of the levee looking upstream.</p>	
<p>pkazi_f_20120913_706.jpg</p>

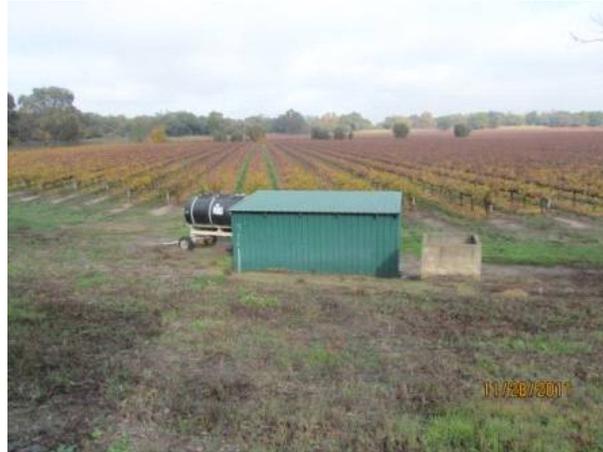
Levee Mile Report Line	90
Start Levee Mile	7.82
End Levee Mile	7.82
Location	Land Side
Category	Earthen Levee
Item	Encroachments
Equipment was found on the landside of the levee looking upstream.	
pkazi_f_20120913_673.jpg

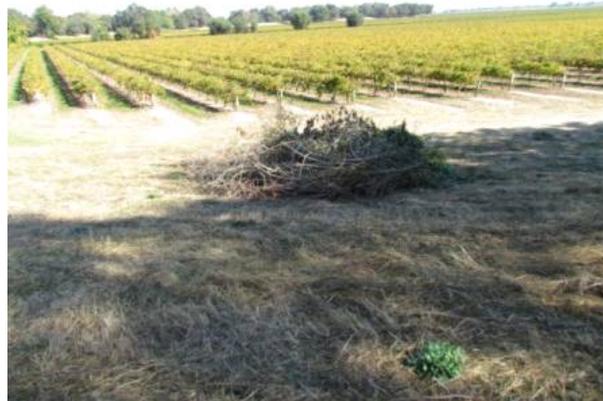
Levee Mile Report Line	91
Start Levee Mile	7.85
End Levee Mile	7.85
Location	Land Side
Category	Earthen Levee
Item	Encroachments
Pruning was found on the landside toe of the levee looking from the crown.	
pkazi_f_20121101_990.jpg

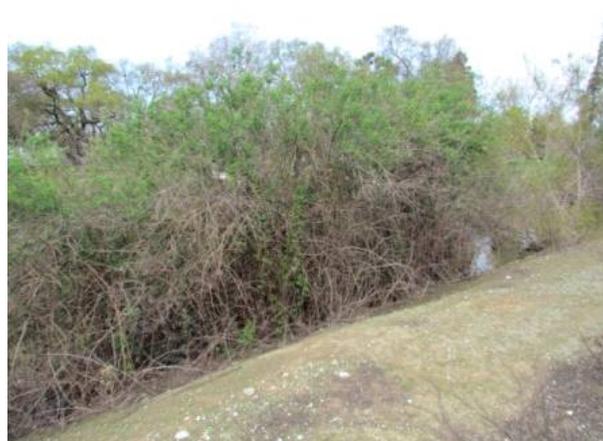
Levee Mile Report Line	92
Start Levee Mile	7.86
End Levee Mile	7.86
Location	Water Side
Category	Earthen Levee
Item	Trim / Thin Trees
Tree branches were blocking the visibility of the waterside of the levee looking upstream.	
pkazi_f_20120913_737.jpg

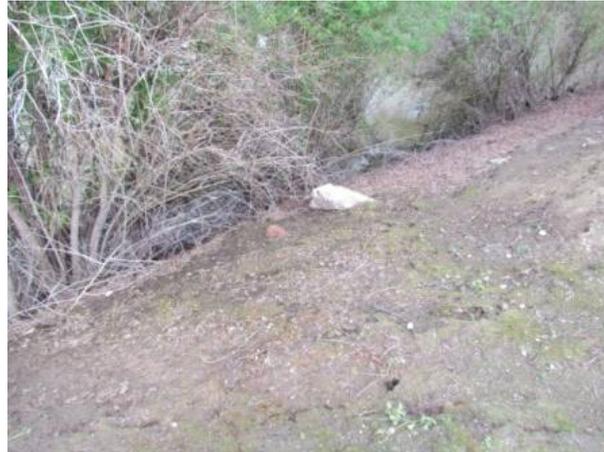
An abandoned pipe was found on the waterside of the levee looking upstream.

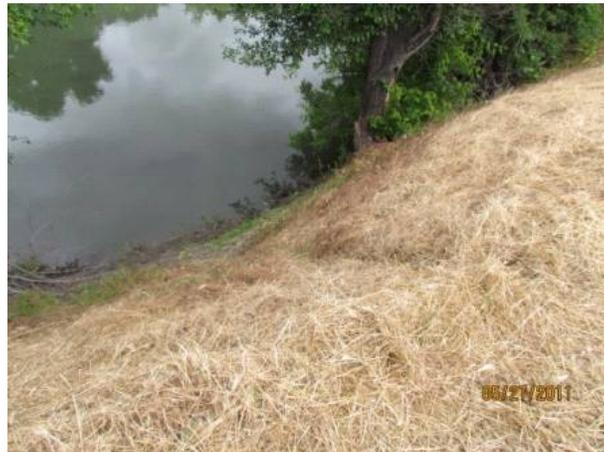
Levee Mile Report Line	97
Start Levee Mile	8.48
End Levee Mile	8.48
Location	Water Side
Category	Earthen Levee
Item	Erosion / Bank Caving

Slope instability on the waterside slope of the levee. The picture was taken from the crown looking upstream.

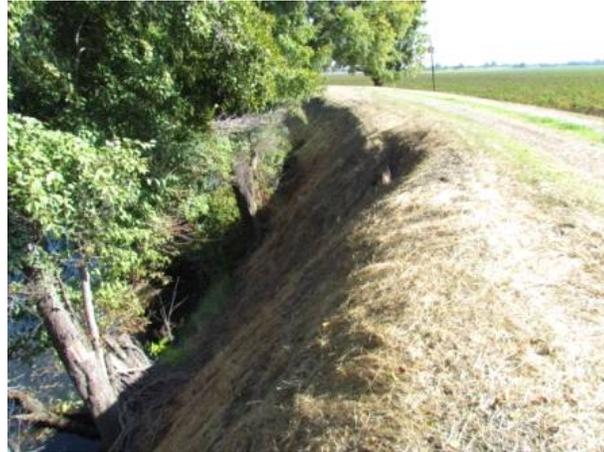
Slope instability was found on the waterside shoulder of the levee looking upstream. This picture was taken during fall 2012 inspection.

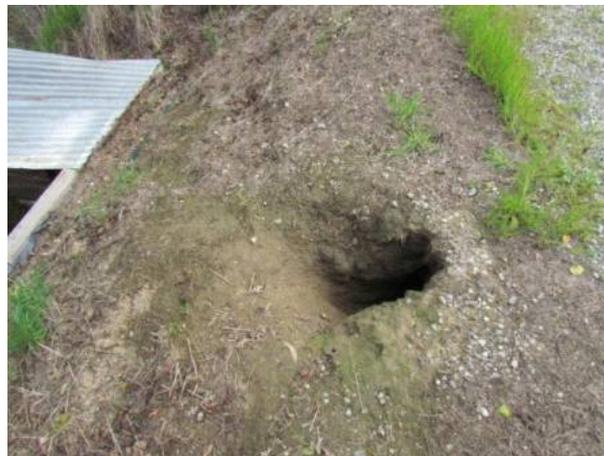
Levee Mile Report Line	98
Start Levee Mile	8.52
End Levee Mile	8.52
Location	Water Side
Category	Earthen Levee
Item	Animal Control

A rodent hole was found on the waterside of the levee looking upstream.

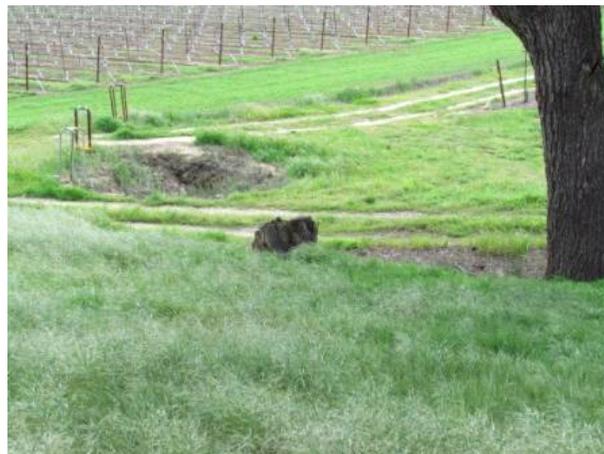
Levee Mile Report Line	101
Start Levee Mile	8.62
End Levee Mile	8.62
Location	Land Side
Category	Earthen Levee
Item	Trim / Thin Trees

A tree stump was found on the landside of the levee looking upstream.

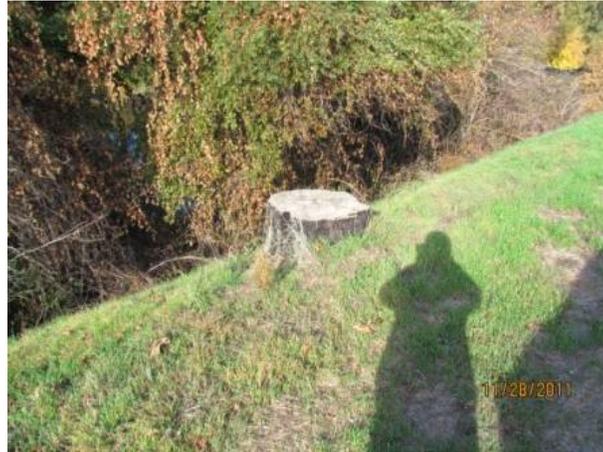
Levee Mile Report Line	102
Start Levee Mile	8.65
End Levee Mile	8.65
Location	Water Side
Category	Earthen Levee
Item	Trim / Thin Trees
<p>A tree stump was found on the waterside of the levee looking upstream.</p>	
<p>pkazi_f_20120913_707.jpg</p>

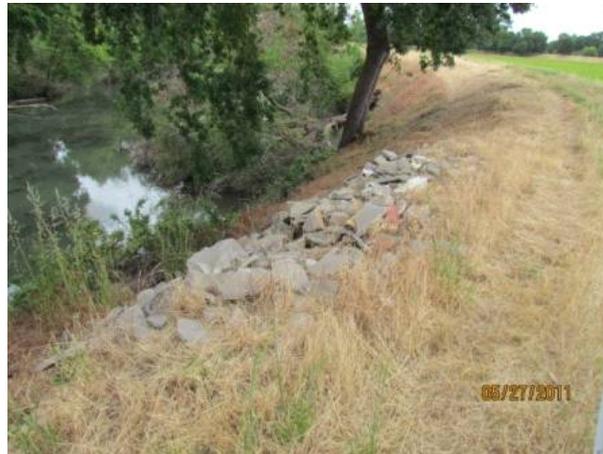
Levee Mile Report Line	104
Start Levee Mile	8.87
End Levee Mile	8.87
Location	Water Side
Category	Earthen Levee
Item	Encroachments
<p>Broken concrete pipe was left on the waterside slope of the levee. The picture was taken from the crown looking upstream.</p>	
<p>pkazi_f_20120913_662.jpg</p>

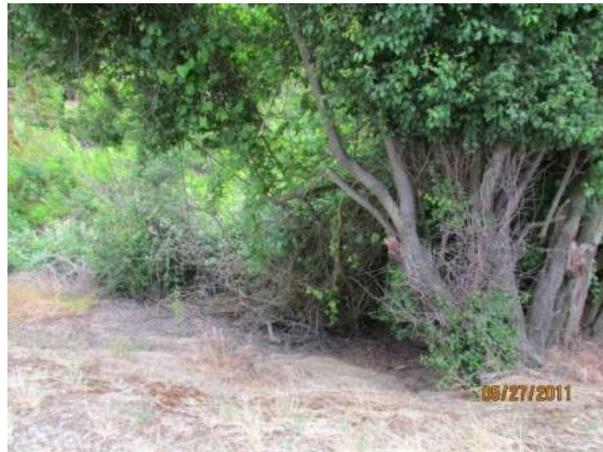
Levee Mile Report Line	105
Start Levee Mile	9.35
End Levee Mile	9.35
Location	Water Side
Category	Earthen Levee
Item	Trim / Thin Trees
<p>Trees needed to be trimmed for visibility of the waterside slope of the levee. The picture was taken from the crown looking towards the slough.</p>	
<p>pkazi_f_20120913_724.jpg</p>

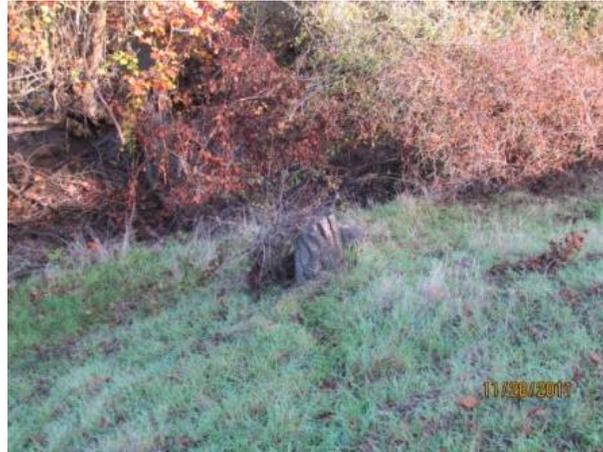
Levee Mile Report Line	106
Start Levee Mile	9.38
End Levee Mile	9.38
Location	Water Side
Category	Earthen Levee
Item	Trim / Thin Trees
<p>A tree stump was found on the waterside of the levee looking upstream.</p>	
<p>pkazi_f_20120913_711.jpg</p>

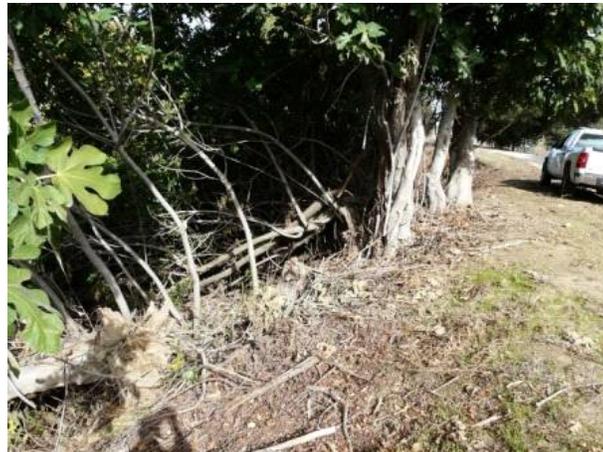
Levee Mile Report Line	107
Start Levee Mile	9.51
End Levee Mile	9.51
Location	Water Side
Category	Earthen Levee
Item	Trim / Thin Trees
<p>Thin/trim trees to allow for visibility of top 20' of waterward slope at LM 9.51.</p>	
<p>pkazi_f_20120913_725.JPG</p>

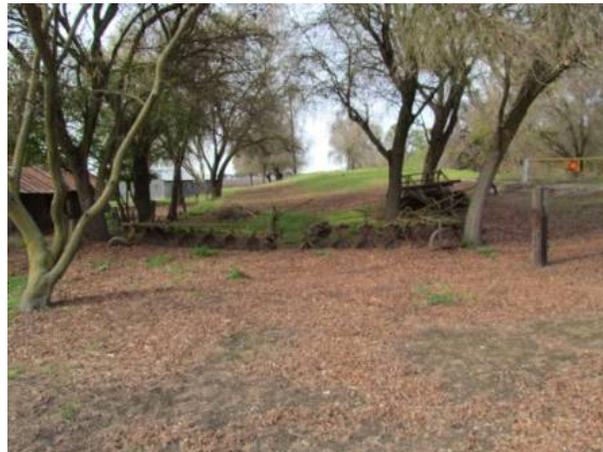
Levee Mile Report Line	109
Start Levee Mile	9.56
End Levee Mile	9.56
Location	Land Side
Category	Earthen Levee
Item	Encroachments
<p>Equipment was found on the landside of the levee looking downstream.</p>	
<p>pkazi_f_20120913_754.jpg</p>
